Sewage work in Großglattbach

In Großglattbach, Germany, a sewage work was constructed in July 1998. A surface that was resistant to penetration and durable to repeated high pressure cleaning was specified. Furthermore a void-free surface was required.

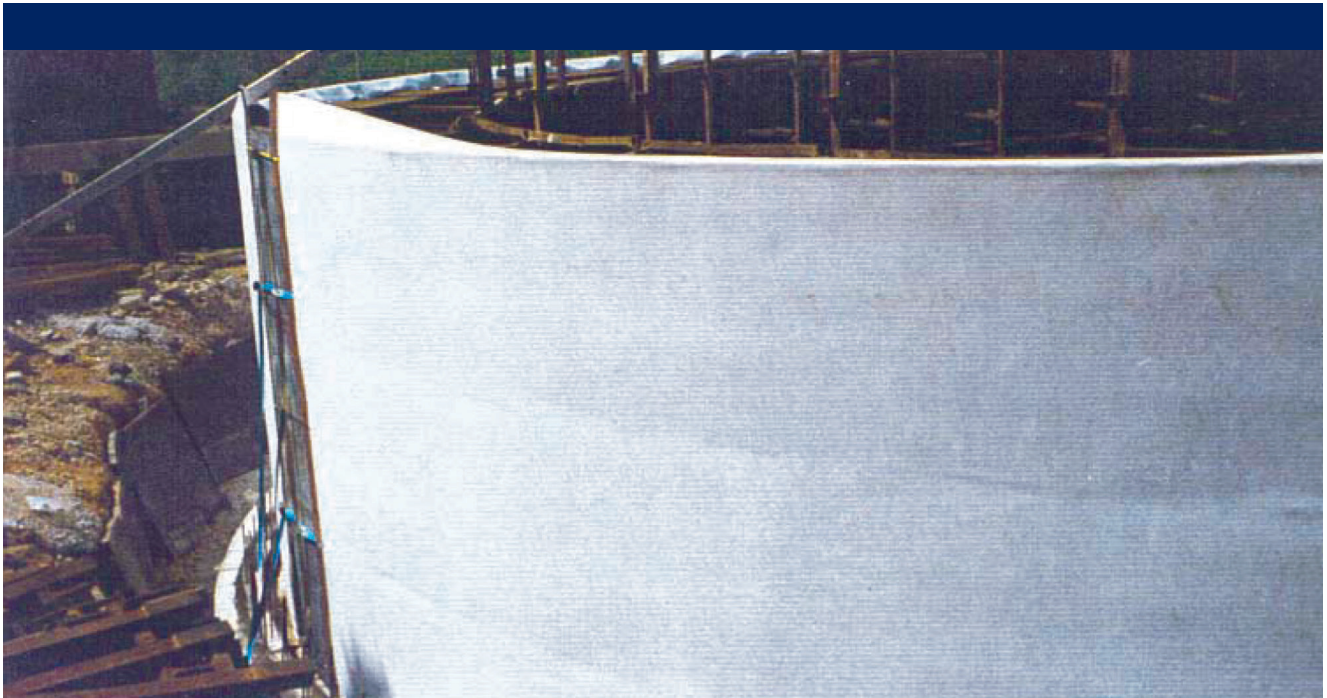
Figure 1. The formwork lined with Formtex® before casting of a wastewater tank for the sewage work.

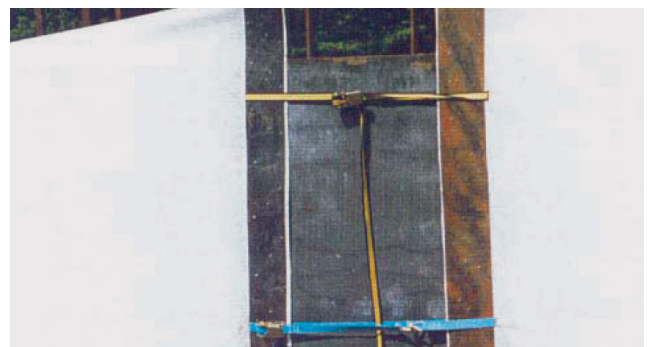
Figure 3. The liner is tensioned with clamps.

A new tensioning method was used: Formtex® was rolled around the formwork and tensioned vertically.
