# Chai Wan Fresh Water Reservoir, Hong Kong

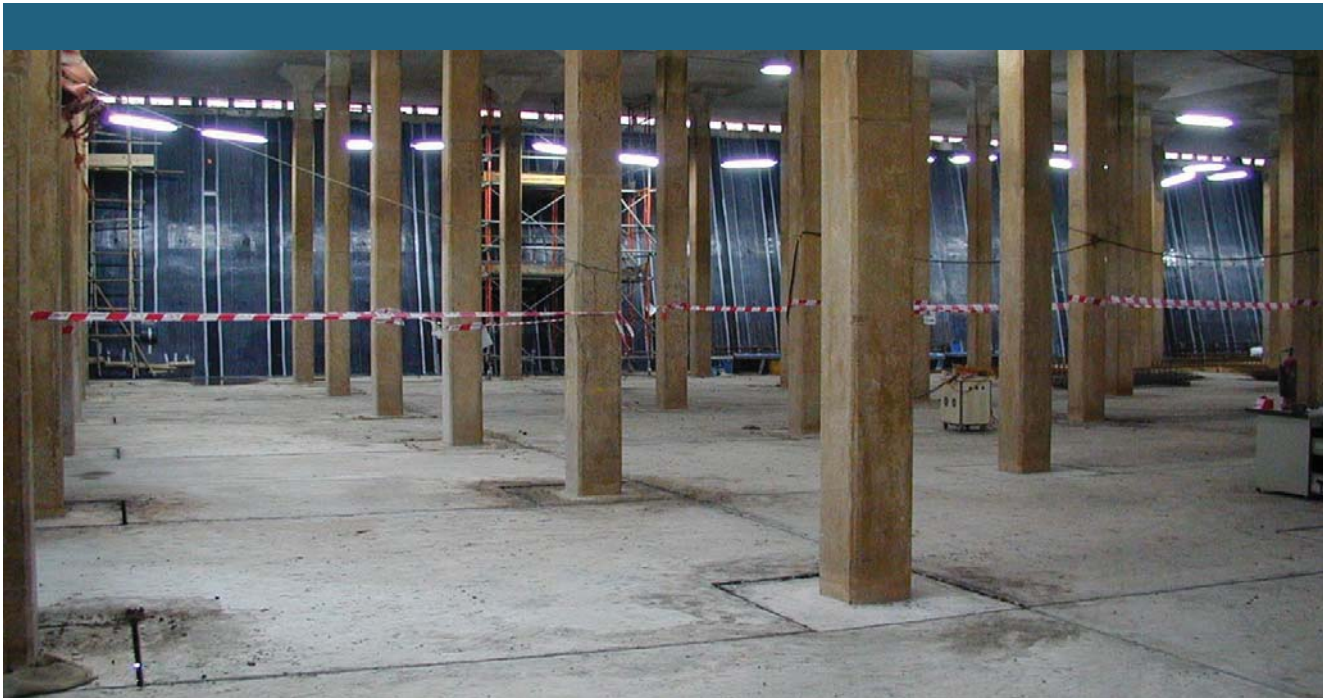
Figure 1: The construction site of Water Service Reservoir.

In February 2003, the maintenance work of Chai Wan Fresh Water Service Reservoir commenced. A self-compacting concrete was designed in which a Superplasticizer additive is added and no vibration is required. However, the result was not satisfactory, the concrete surface was full of large and small blowholes and not dense enough. Accordingly, Formtex® was introduced to solve the problem.

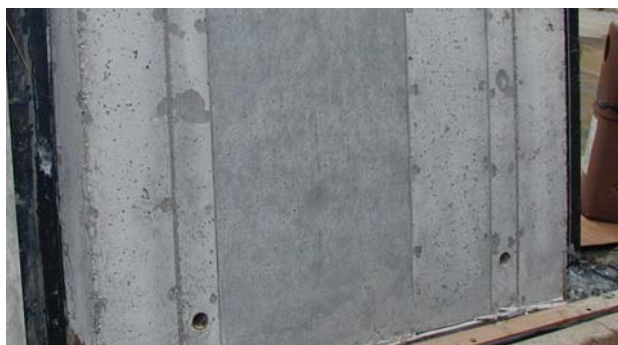
Figure 2. A trial for installation of Formtex® (middle).

A trial was carried out in March 2003 to verify the effect of Formtex® CPF liner. The result was very obvious and impressive. The number of blowholes was greatly reduced and a dense concrete surface was achieved.

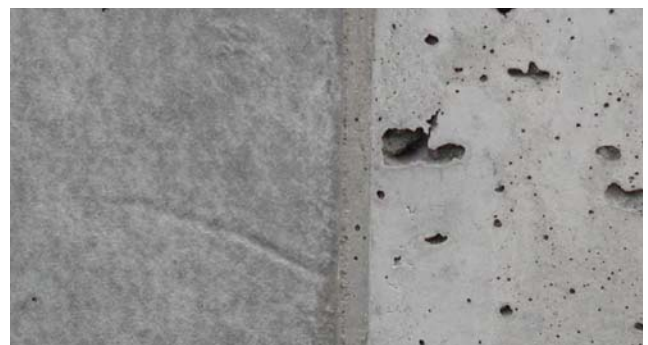
Figure 3. Concrete surface achieved with Formtex® (left) and without Formtex® (right).

In view of the outstanding performance of Formtex® that improved the quality of the concrete surface, Formtex® was used in the casting of all the remaining concrete.
