Sewage work in Großglattbach

In Großglattbach, Germany, a sewage work was constructed in July 1998. A surface that was resistant to penetration and durable to repeated high pressure cleaning was specified. Furthermore a void-free surface was required.

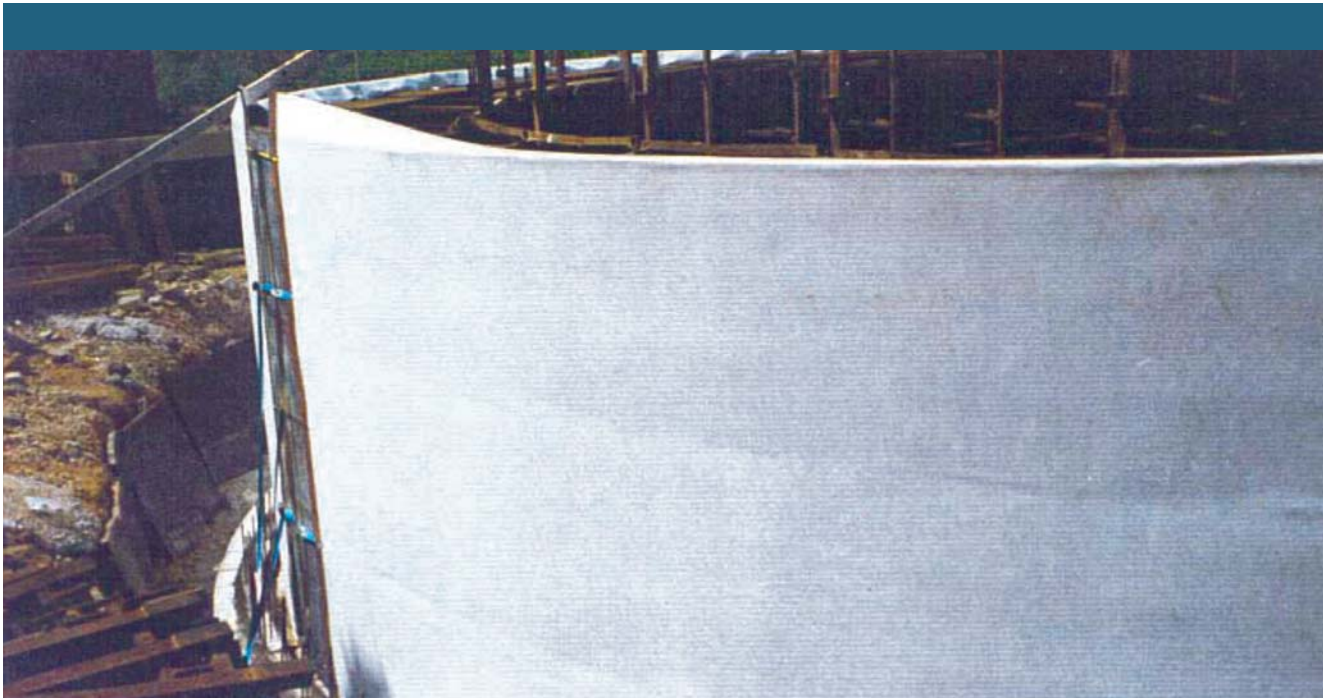
Figure 1. The formwork lined with Formtex® before casting of a wastewater tank for the sewage work.

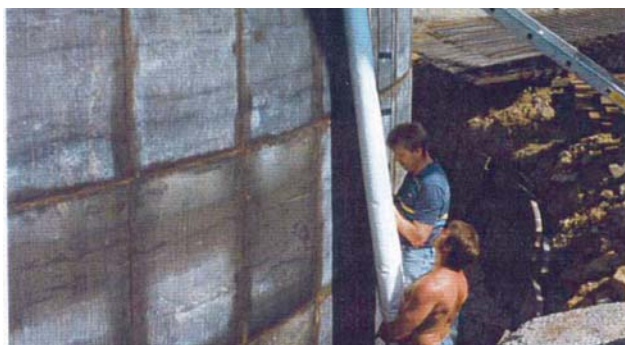
Figure 2. The roll is prepared for tensioning.

Formtex® was used for this project. The liner was only used once as a new tensioning method was tested.

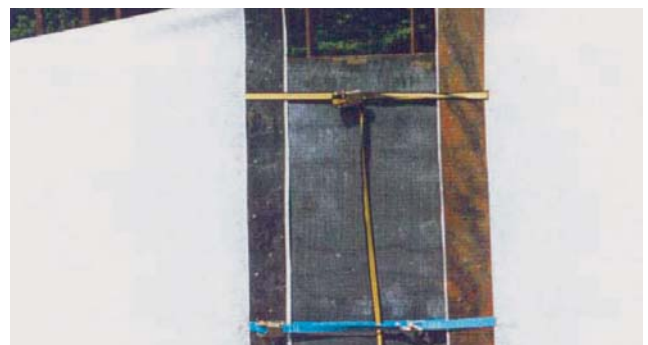
Figure 3. The liner is tensioned with clamps.

A new tensioning method was used: Formtex® was rolled around the formwork and tensioned vertically.
