The world's largest land reclamation

- based on Fibertex Geotextiles

Hong Kong International airport

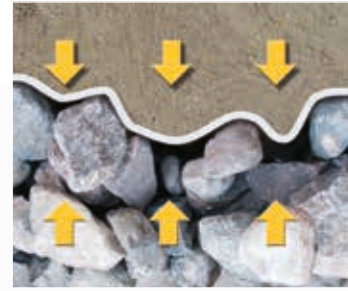
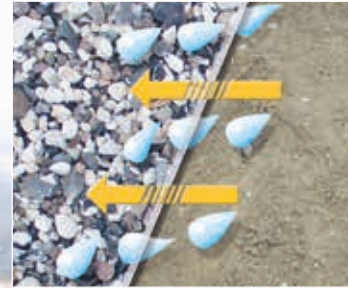
Testing the quality

To test if any damage would occur during installation, Fibertex F-4M was installed in a trial construction. After compaction the sand was carefully removed and the following inspection showed that the Fibertex geotextile was undamaged. Its separation and filtration ability remained unchanged.

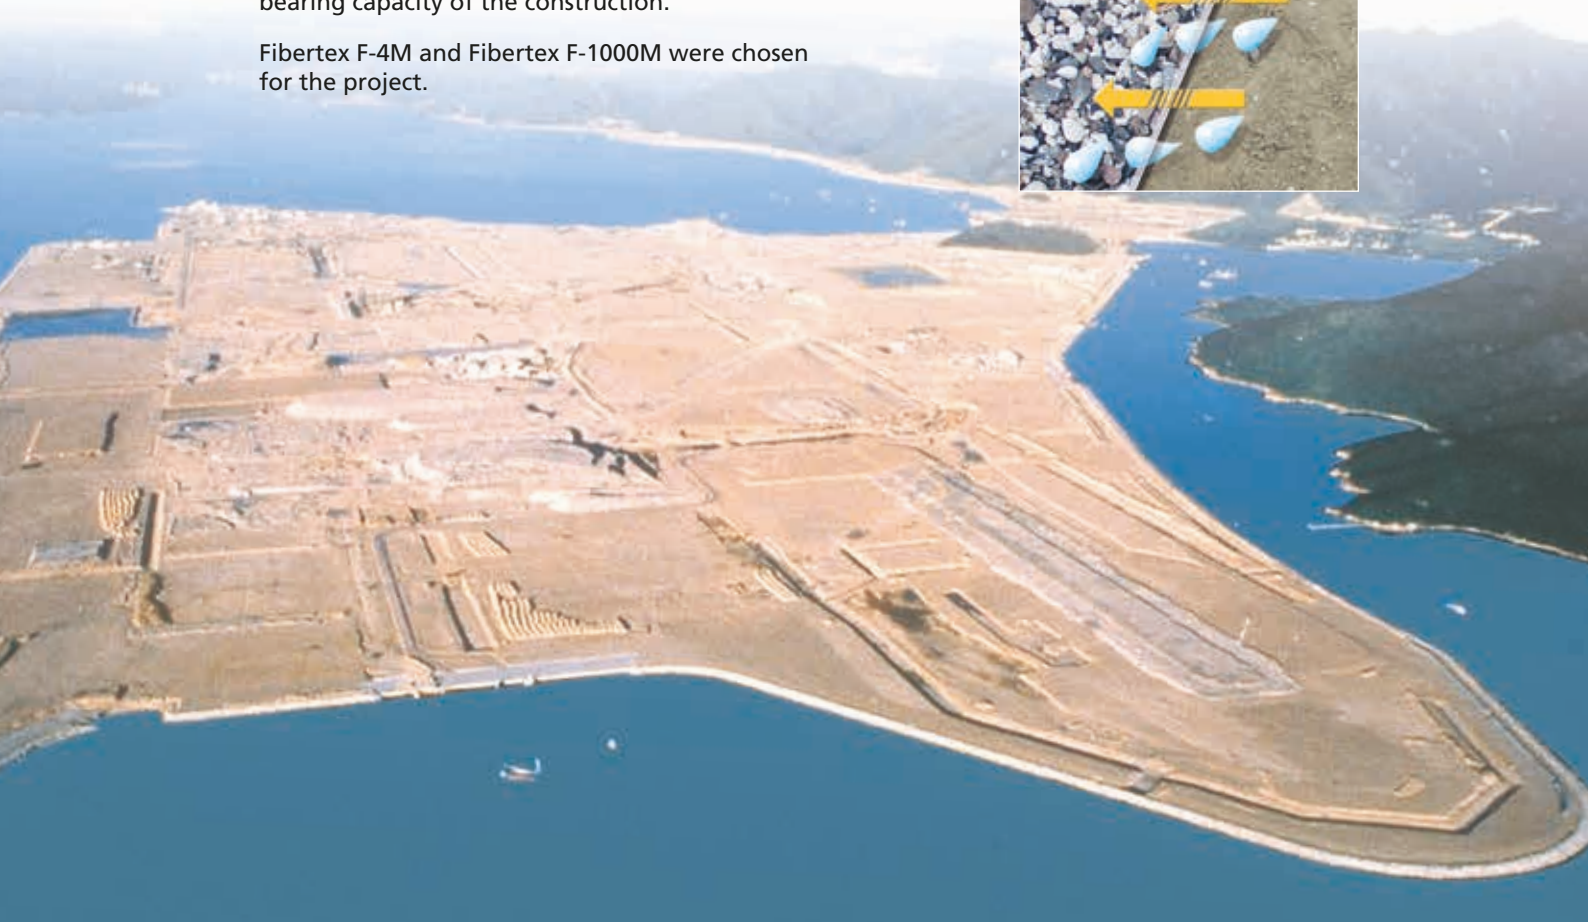
Separation

Filtration

Geotextile functions

To stabilize the subbase and prevent migration and mingling of materials and still allowing free movement of water, a strong and flexible geotextile is placed between the different layers.

High puncture resistance to resist the strains of installation (large stones) and use in general is decisive for the load-bearing capacity of the construction.

At the coastline a geotextile with excellent hydraulic properties to prevent fines from being washed out by the waves while maintaining free movement of water is decisive for the load-bearing capacity of the construction.
